Transformer failures in regions incorrectly considered to have low GIC-risk

C. T Gaunt, G. Coetzee

Index Terms— Power transformers, Failure analysis, Geomagnetically induced currents.

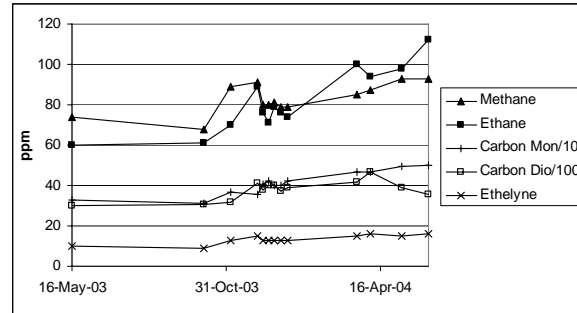
geomagnetic storms. The DGA record for one of the Matimba transformers, shown in Fig 5, is fairly typical. Gas levels fell when the transformer loading was reduced following the sharp increase after 31 October. By August 2004, about 10 months after the storm, this transformer had not yet failed, although damage was evident from the generation of gases.

Fig 5: DGA results Matimba #1: May 2003 to June 2004

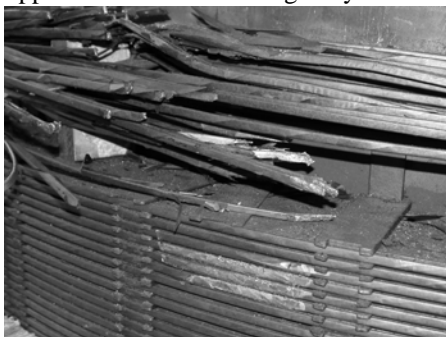
In the transformer depicted in Fig 6 the level of CO_2 , a product of low temperature degradation of cellulose, was approximately 10 times higher than the level of CO . Relatively higher CO or ethylene content would indicate higher temperature degradation.

Inspections of all the failed transformers identified heat damage, mostly to paper insulation, in various parts of the transformers, as illustrated in Figs 6 to 8. The damage is consistent with the DGA results. In all cases, the extent of the damage appears to be small, and discoloration of paper insulation beyond the immediate vicinity of the fault is superficial, which explains why the absolute levels of dissolved gas are low - even below the threshold considered significant for most DGA assessment.

Fig 6: Failure in HV winding of Lethabo #6

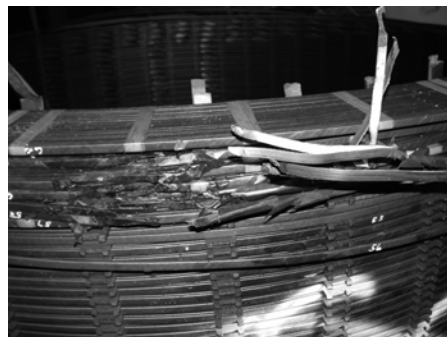
Fig 7: Failure in HV winding of Matimba #4

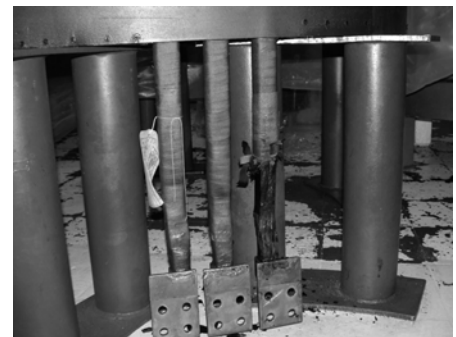
Fig 8: Overheating of LV terminals of Tutuka #1

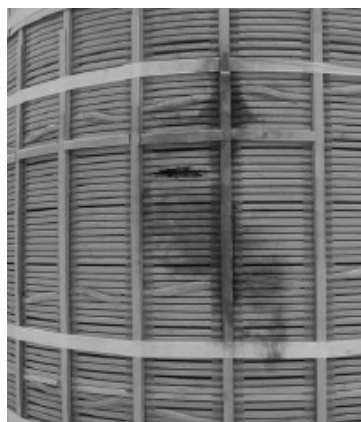
A further event reduces the possibility of a common failure cause other than GICs. On 11 December 2003 the protection tripped a two-year old 90 MVA 330 kV GSU at NamPower's Ruacana power station in northern Namibia. The damage within part of one HV winding, shown in Fig 9, was similar to that of the transformers shown in Figs 6 and 7. Ruacana is on the same synchronous network as the other stations where transformer damage occurred during the same period, but is separated physically by 1400 km and electrically by over 2000 km of circuit. All these stations were found to be among the most "GIC exposed" installations in Southern Africa [7].

Fig 9: Damaged HV winding of Ruacana GSU transformer

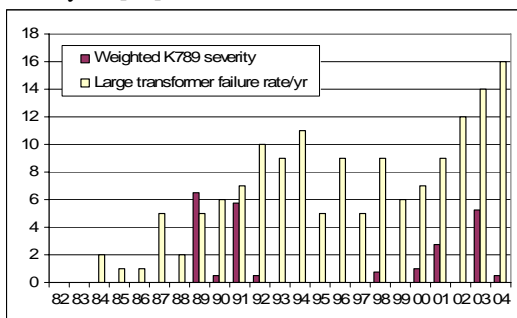
Extreme GIC events do not occur only at the peak of or late in a solar cycle [21] and final failure may not easily be linked to the solar cycle or a specific storm. However, based on these responses to GICs, it would be expected that transformer failures should increase during periods following geomagnetic storms. Such a trend is evident from an analysis of failures of large transformers, all over 230 kV, on the Eskom MTS during the past 20 years. The failure for winding, core or lead damage of 143 large transformers appears to increase after storm events, as shown in Fig 10. The storm severity indicator is based on the geomagnetic storm periods during the year, with K7 and K8 occurrences weighted as 0,25 and 0,5 respectively compared with a K9 occurrence. It is recognised that K values measured at the HMO are a crude indication of the severity of storms in respect of producing GICs, but in the absence of a better index, this composite value has been used. The higher incidence of transformer failures during the years after geomagnetic storms is similar to that reported for transformers in North America relative to the solar cycle [22].

Fig 10: Annual failures of large transformers with winding, core or lead damage, relative to the severity of geomagnetic storms. (2004: based on half year result.)
